Citroën-Kégresse in Iceland

The Citroën-Kégresse P15N

P15 N in Skógar museum - car no. 2

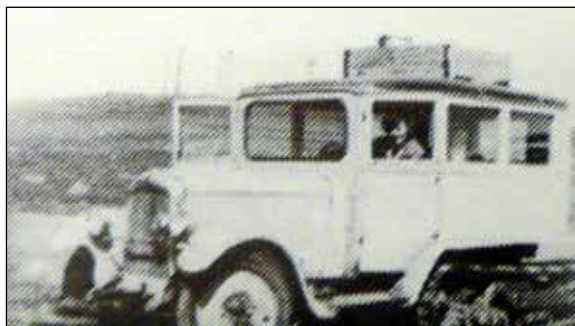
This photo is from the Ystafell Museum catalog.

This car from the second delivery in 1930 is no. 3. The front of the body has been altered, making it easier to put in a new windscreen.

In the beginning this car was sent on a ship to Reyðarfjörður in the east but two years later it was sent to Holtavörðuhéiði. Later it was mainly used in the east on Fagridalur near Egilsstaðir. In 1960 it was sold to Reyðarfjörður but two years later it broke down in Fjarðarheiði between Seyðisfjörður and Egilsstaðir. Here it was abandoned and left outside being vandalized piece by piece.

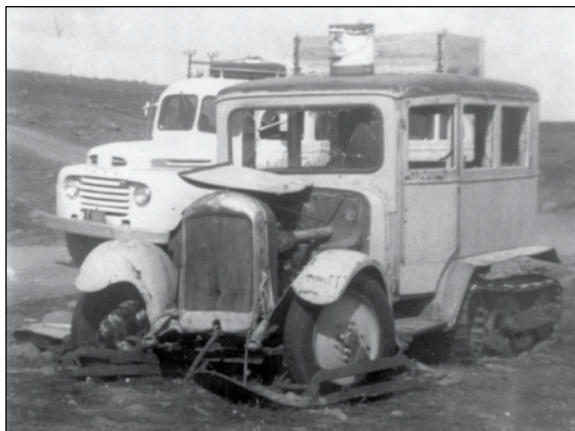
Just after the car broke down.

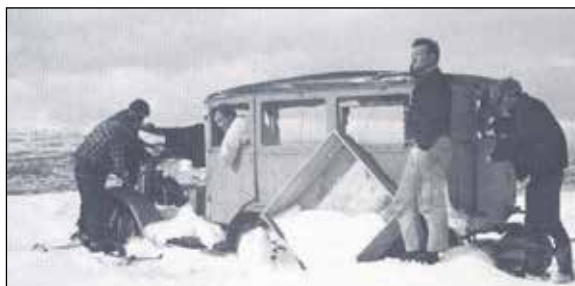
Fjarðarheiði, close to Norðurbrún, east Iceland around 1960. It may have been the same grey car that was in this area 30 years earlier, The first Kégresse came in east Iceland in 1931. Picture from Borgþór Magnússon

nússon. The car was given the name Gráni (Grey), it may have been the same car that was here in the area 30 years earlier. The car was not well equipped for driving in steep landscape and was therefore not used much on Fjarðarheiði, but was used more on the flatter land around Egilsstaðir and up to Jökuldalur valley. The car ended its life up on Fjarðarheiði close to Norðurbrún, where the engine overheated and melted down, the front of the car was as if it had later been burned.

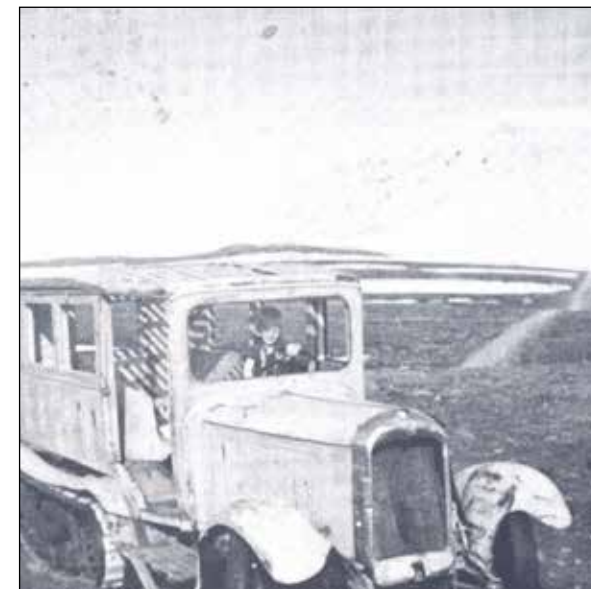
Picture from a book about Sigfús Kristinsson. Fjarðarheiði, close to Norðurbrún. The Kégresse shown some time after it had broken down and left in the fields.

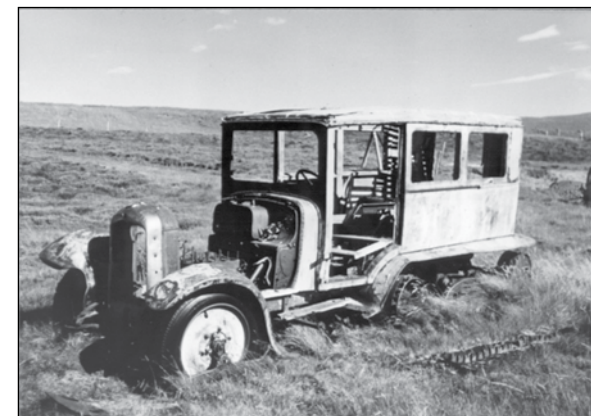
In the late sixties.

In 1966 this Kégresse was saved and stored, first in a warehouse by the Icelandic Road Administration (ICERA) but now it is in a warehouse in the Skógar Museum.

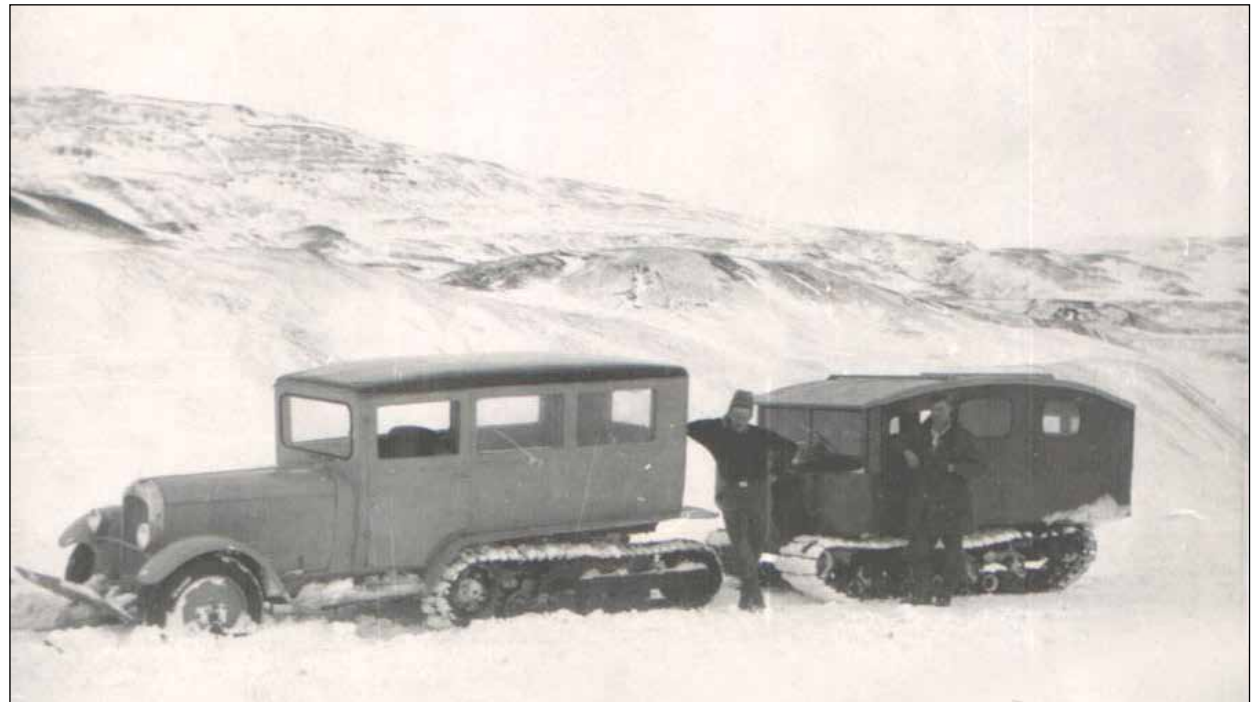
This photo was taken up at Hauksstaðir in the winter of 1961. There you see "Gráni" and another snowmobile, a Studebaker Weasel belonging to Vignir Brynjólfsson, probably the first snowmobile that Þorbjörn Arnoddsson owned. Gráni had broken down when the photo was taken and the Studebaker Weasel went to assist. On the photo you see Svavar Sigurðsson, leaning towards Gráni and Vignir.

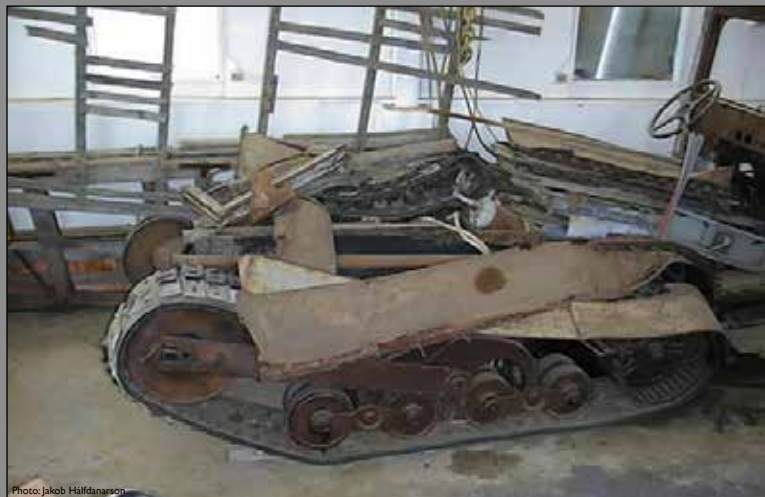
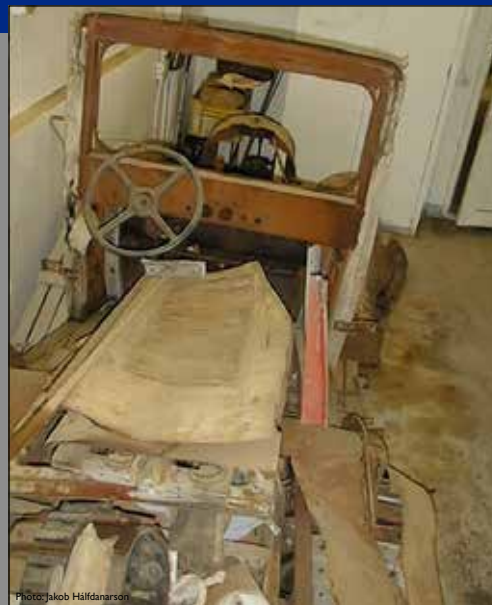
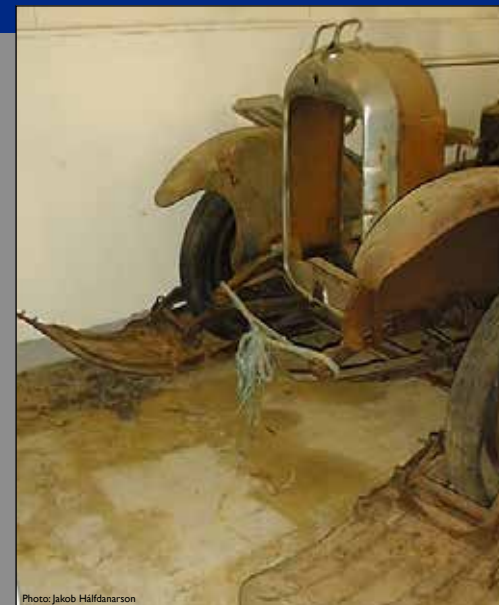
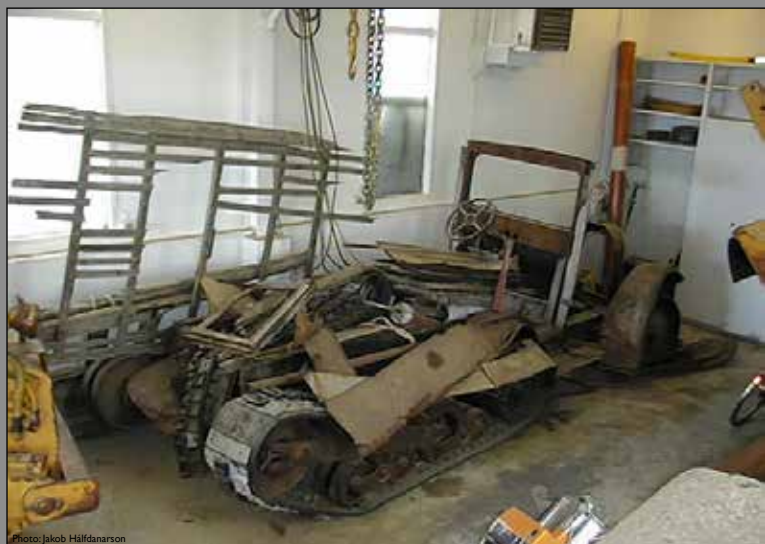
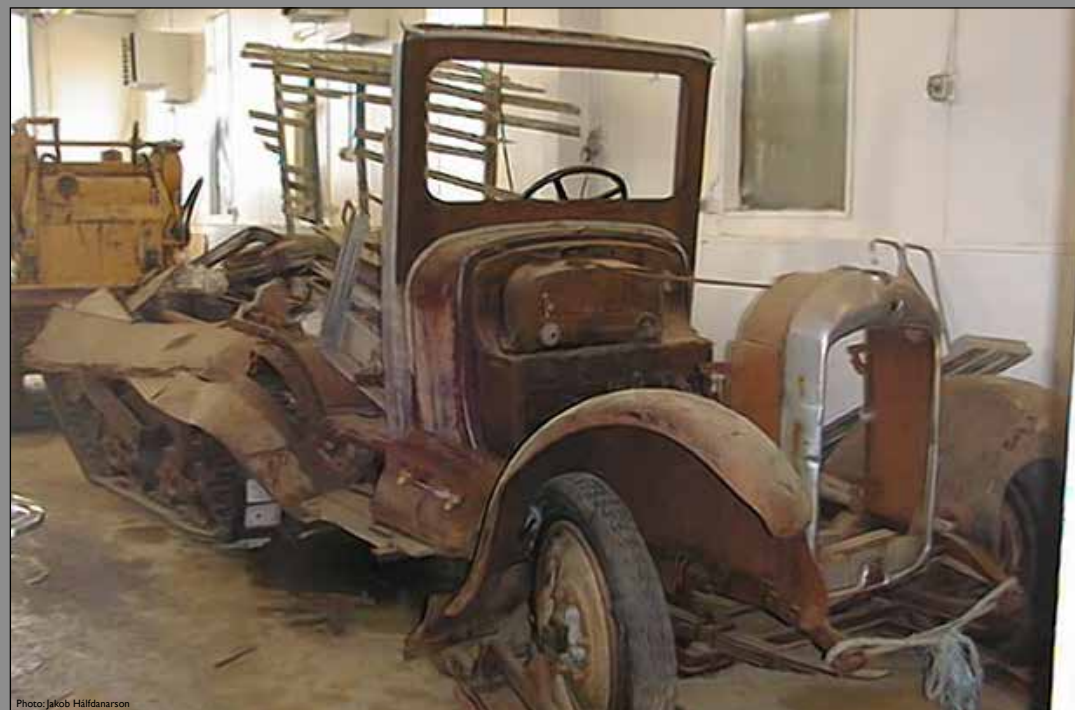
Gráni today

These pictures are taken in 1998 by Jakob Hálfðanarson when Gráni was stored in Selfoss. Today Gráni is in the Skógar Museum.

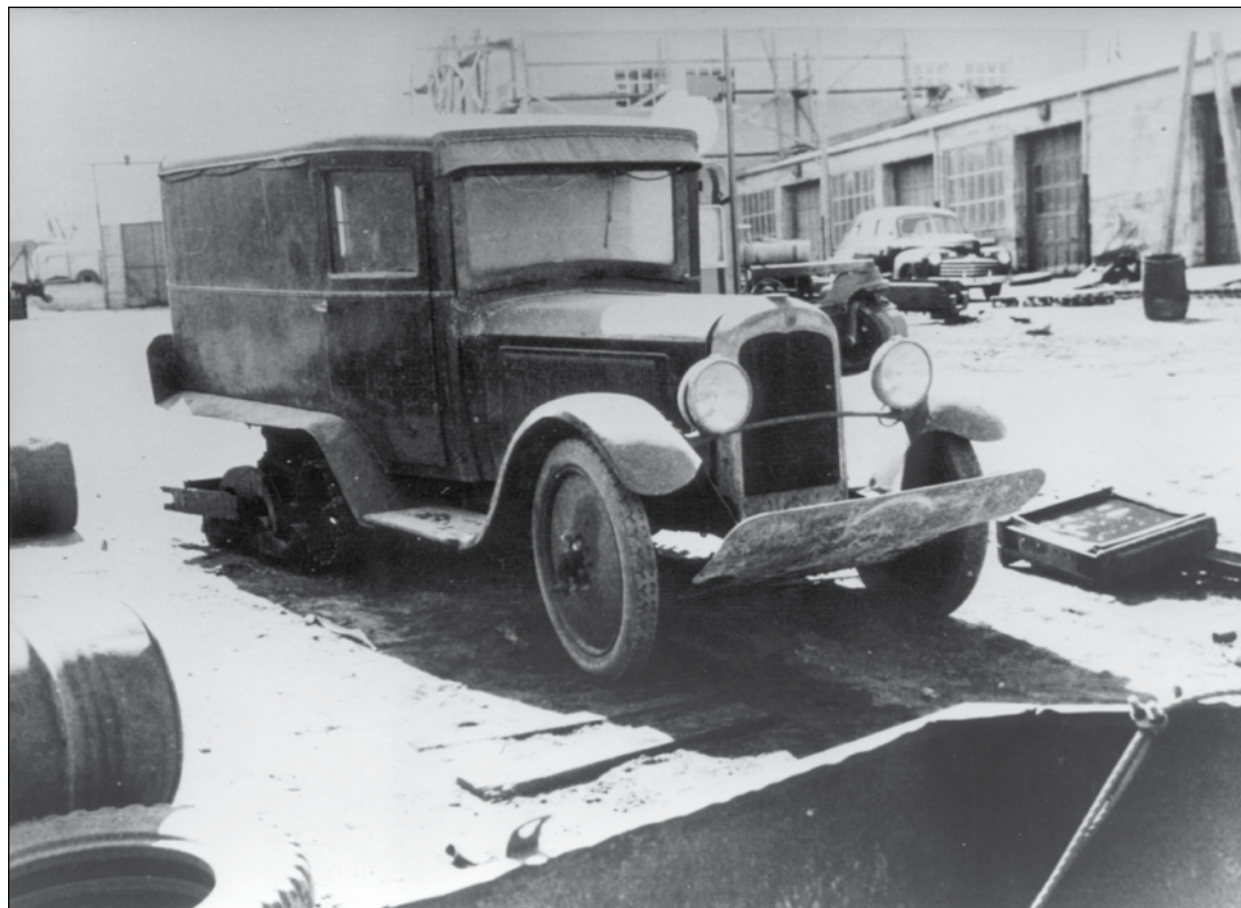
The picture of this Kégresse van was taken in front of the main workshop for the ICERA in Borgartún 5 in Reykja-vik. There is no registration number on the Kégresse so the photo could have been taken in the fifties, after it had been unregistered and the tracks could have been used as spare parts for an another vehicle.

From the second delivery in the end of 1930 this is the last car no. 4. It has a similar body as the others but without any windows in the back. This car was mainly used as a second car in the passage Holtavörðuheiði in the north and in the passage Hellisheiði in the south, transporting a.o. mail and luggage, feed supplements for the animals to the farmers and specially over Hellisheiði the milk from the farmers in south of Iceland towards Reykjavík.
