Citroën-Kegresse on Iceland

The Citroën-Kegresse P15N

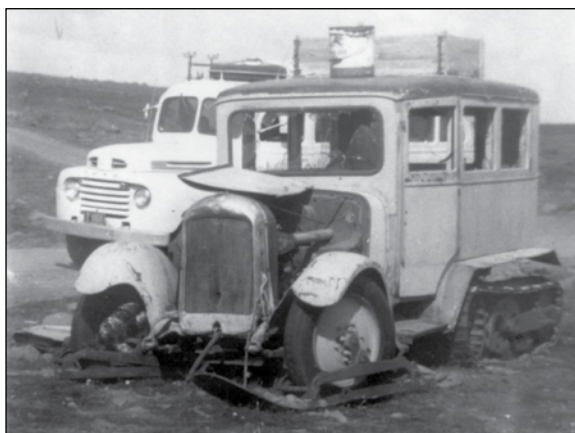
Just after the car broke down.

In the end the car broke down and was left on Fjardarheidi between Seydisfjordur and Egilsstaðir. Here it was abandoned and left outside for about 2 or 3 years, being vandalized piece by piece in this period.

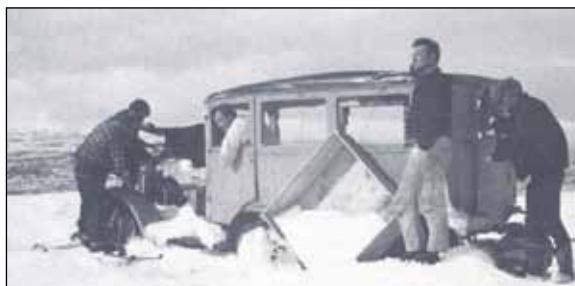
Fjardarheidi, close to Nordurbrun, east Iceland around 1960. It may have been the same grey car that was in this area 30 years earlier, The first Kegresse came in east Iceland in 1931. Picture from Borgþór Magnússon

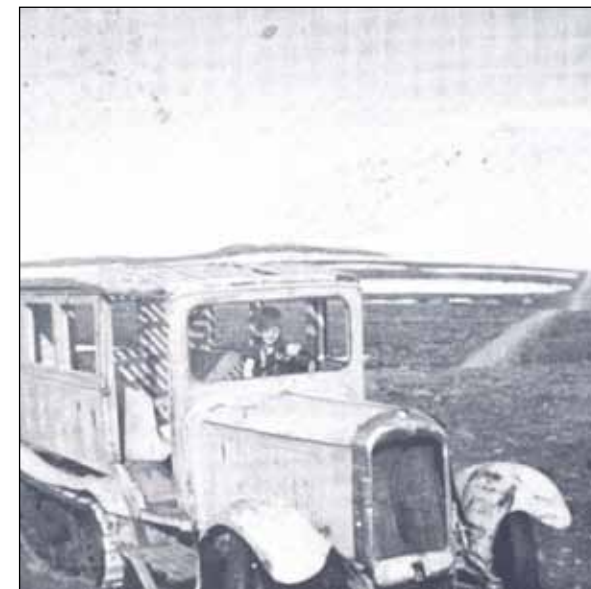
Picture from a book about Sigfus Kristinsson. Fjardarheidi, close to Nordurbrun. The Kegresse shown some time after it had broken down and left in the fields.

The car was not well equipped for driving in steep landscape and was therefore not used much on Fjardarheidi, but was used more on the flatter land around Egilsstadir and up to Jokuldalur valley. The car ended its life up on Fjardarheidi, close to Nordurbrun, where the engine overheated and melted down, the front of the car was as if it had burned after.

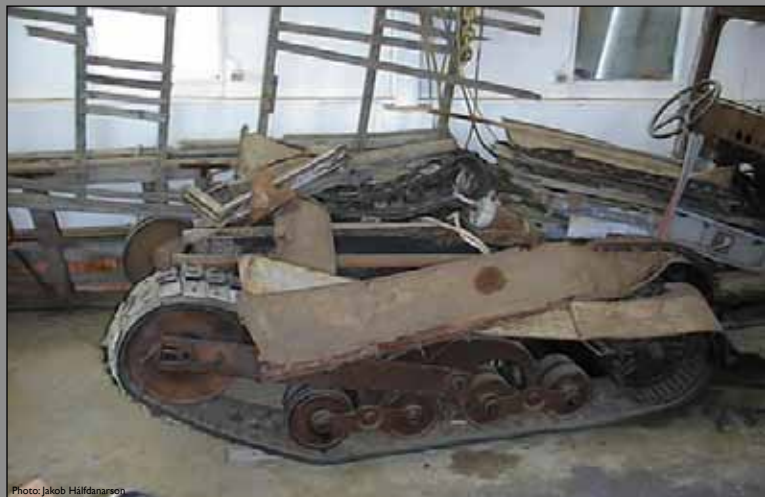
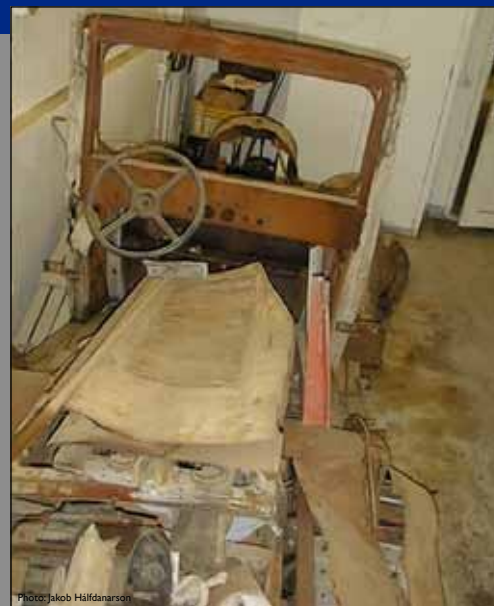
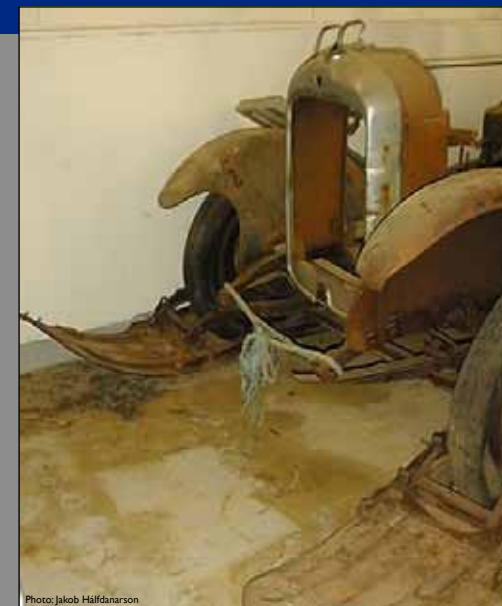
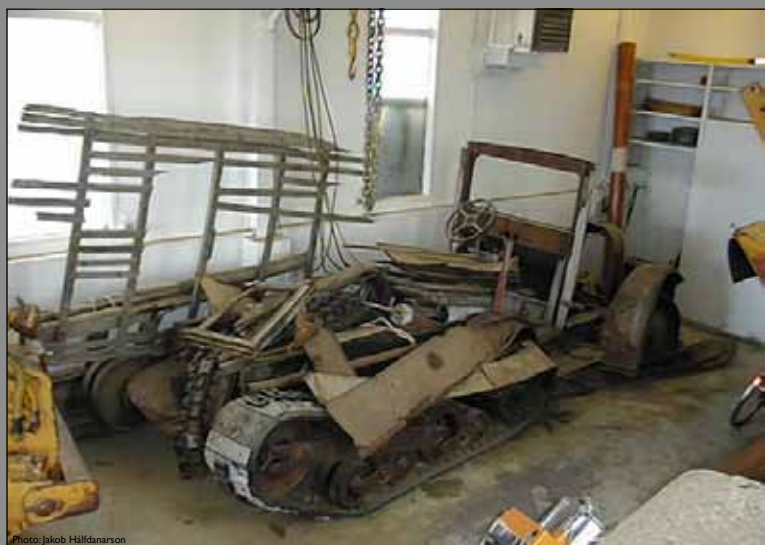
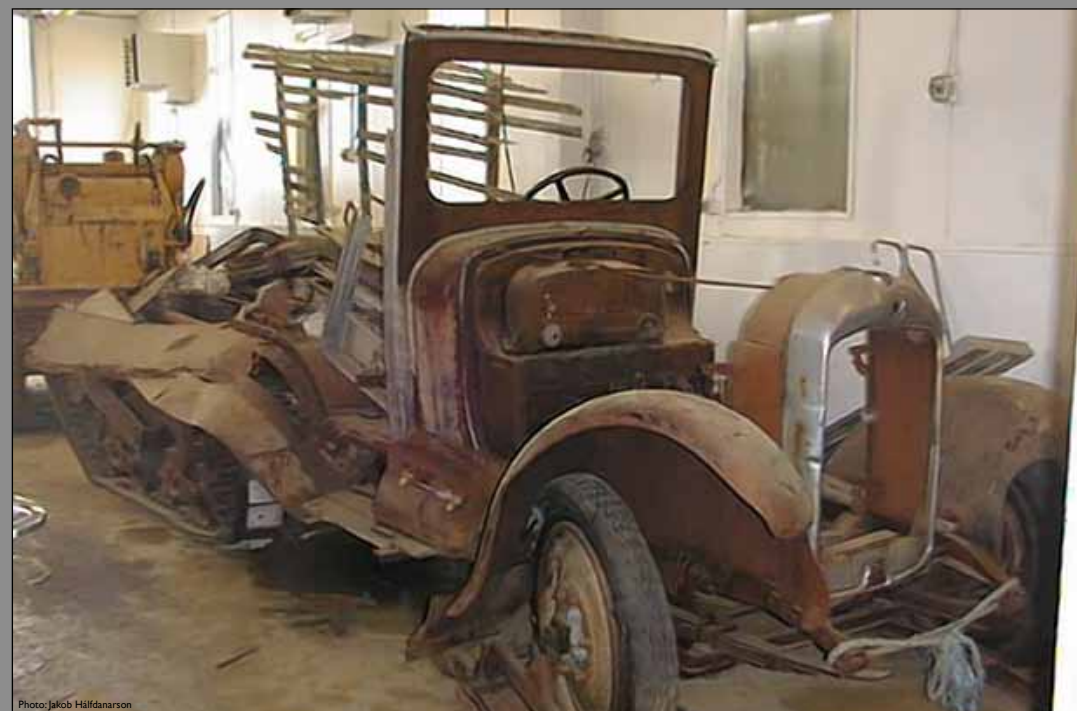
Grani in storage in Selfos by the Icelandic Road Museum. Pictures are taken in 1998 by Jakob Hálfdanarson

One is at the national museum in Skógar. The other is in a warehouse of the Road Maintenance in Selfos. Unfortunately both cars have had their engines replaced with 4-cylinder Ford A engines instead of the original 6 cylinder Citroën-engines.

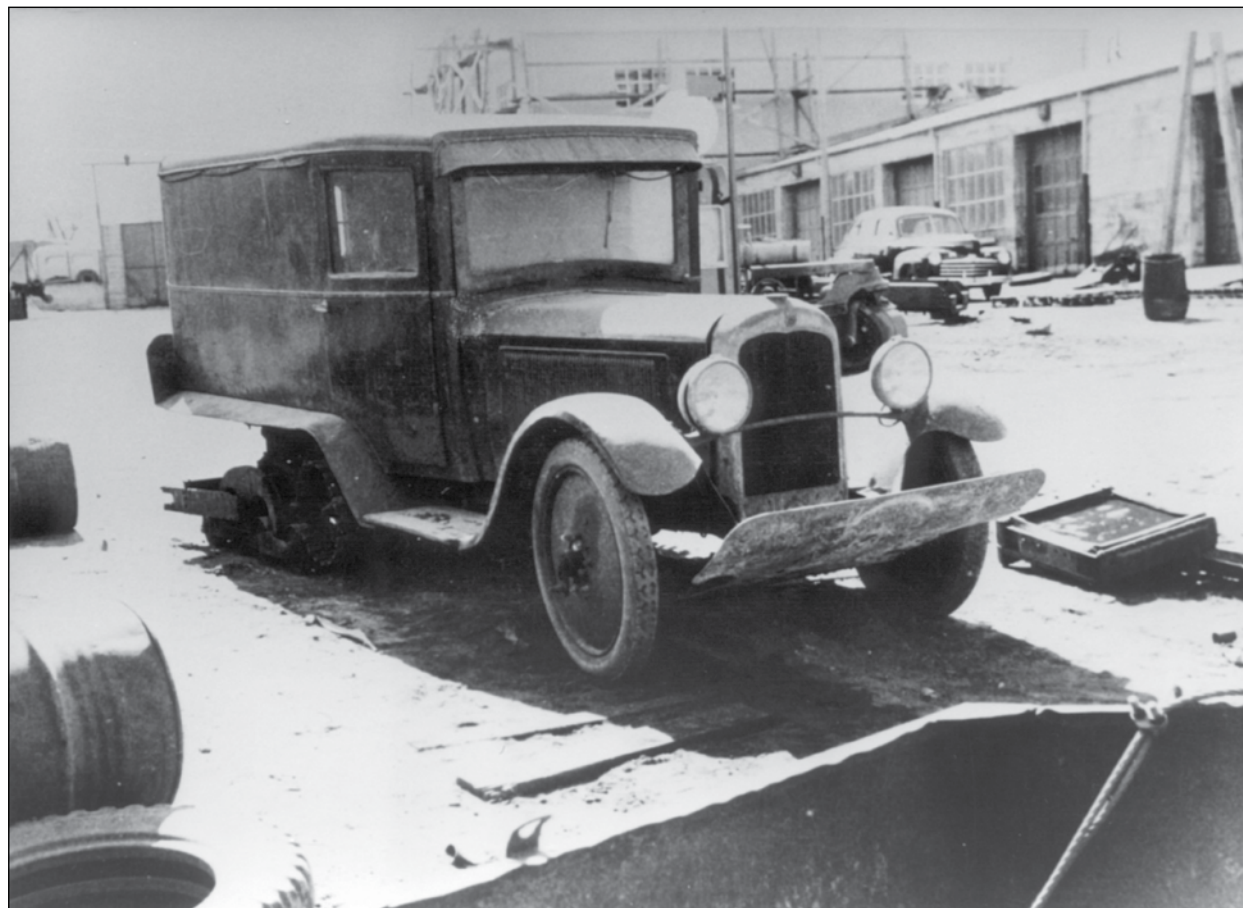
The only picture we have of this Kegresse. Maybe the only Kegresse build as a van?

When this photo was taken (fifties?) the Kegresse-van was obviously out of service. The carrossery seems to be in good shape, but mechanical parts are missing. Who knows the story?

No doubt that this car is a fully equipped P15N – but apart from that we know nothing about the origin and history of it. Was it a service-car serving the Icelandic Road Administration – or was it used for other purposes such as mail delivery?

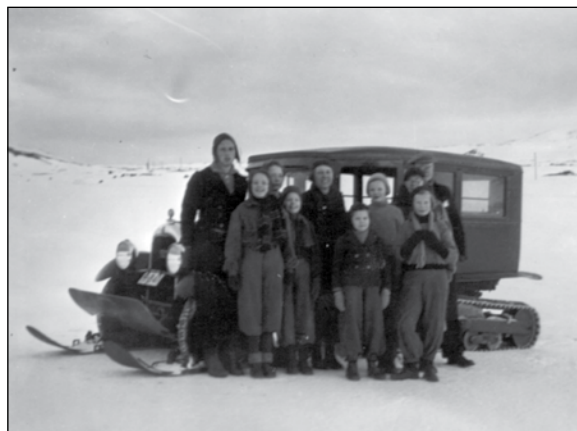
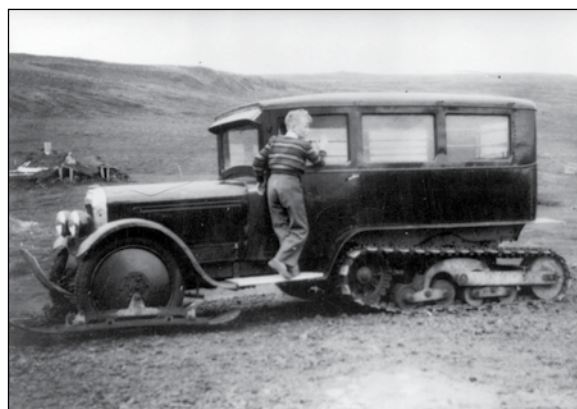
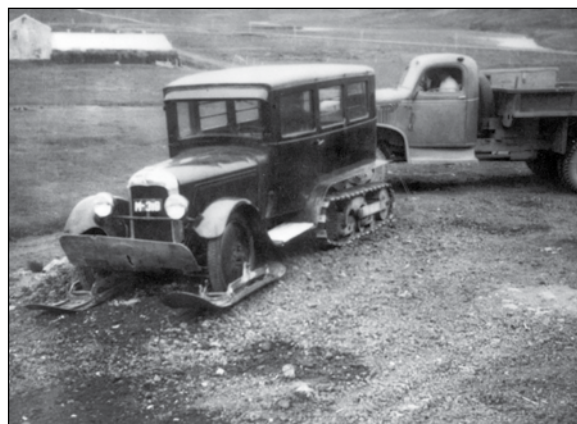
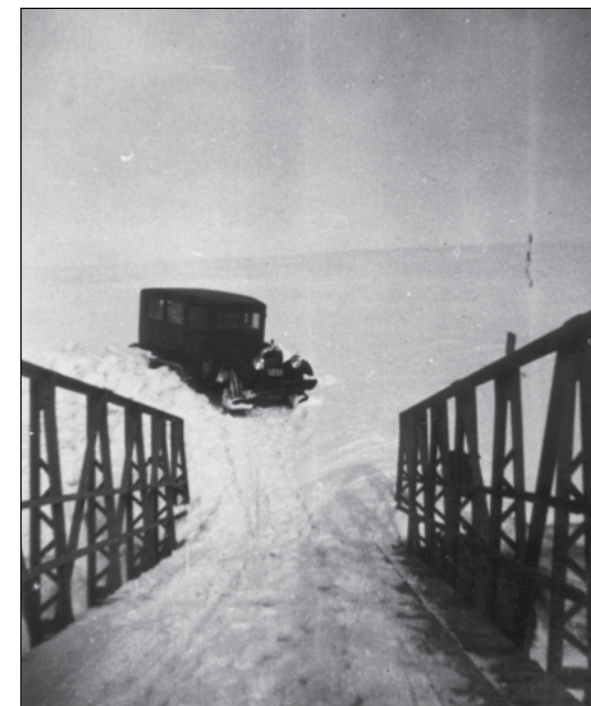
This car is today displayed in Skógar museum in the south Iceland, and it is probably the most complete and well preserved P15N in the world today (see next page).

On some of the photos you see a licence plate, but is not possible to read the number.
